Title: Modification to a Commercial Source Projector Assembly with an Unintended Reduction in the Level of Safety

Date: March 3, 2002

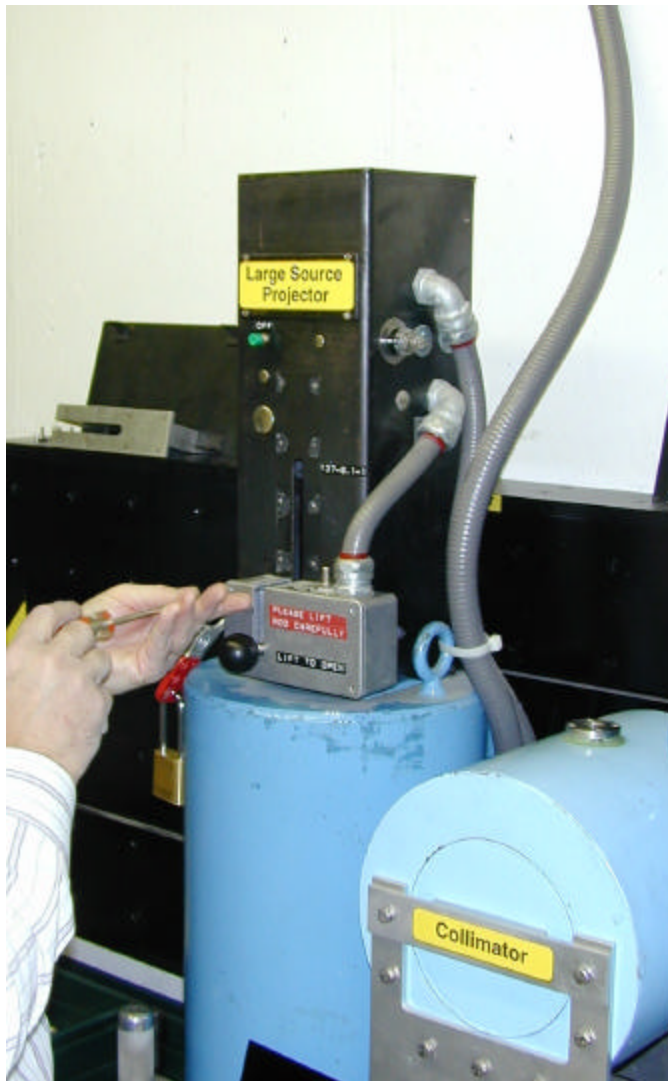
Projector Arm with Shaft in Place

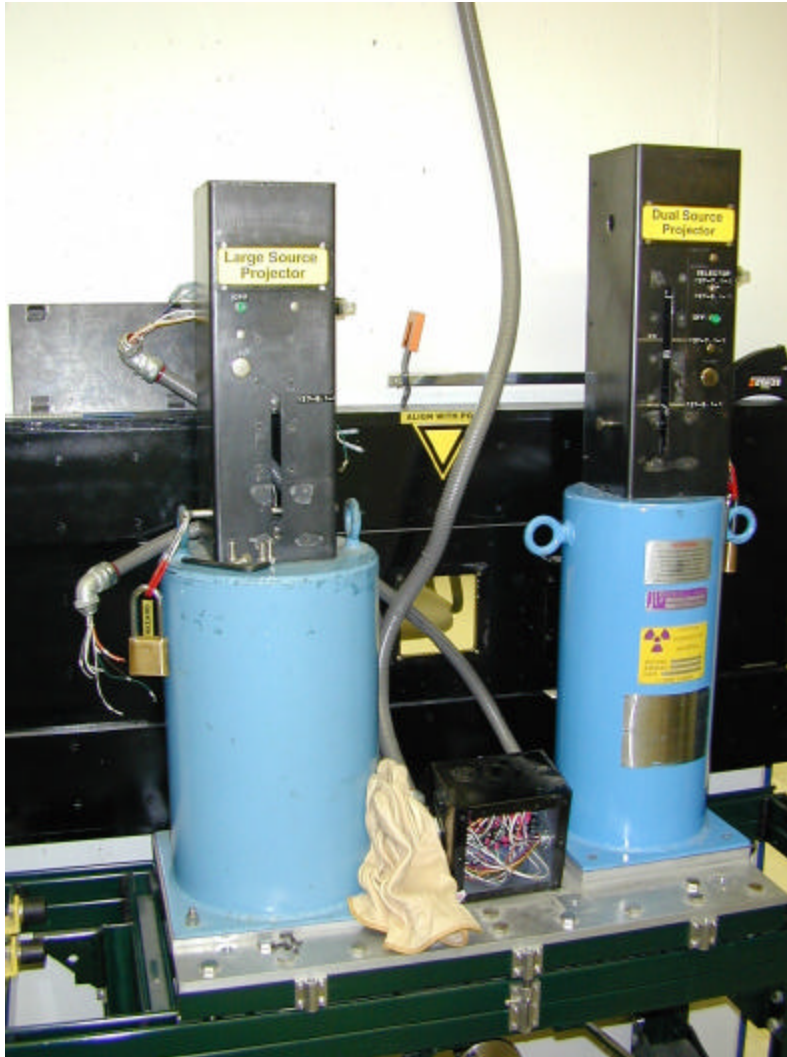
Following the return of the projector with the new source, on January 23, 2002, it was discovered that the locking bar was not effective in preventing the lifting of the source of the single projector into the open position should the source rotate about its axis. This was due to the fact that the locking bar neither intersected the axis of the source rod nor blocked its movement under all angles of rotation. Had the lift arm been left in place, or

Projector Arm with Shaft Removed

had a surrogate such as a piece of threaded rod been installed, this rotational motion would have been rendered impossible and the source would have been held in place.

The vendor was notified of this possible failure mode.

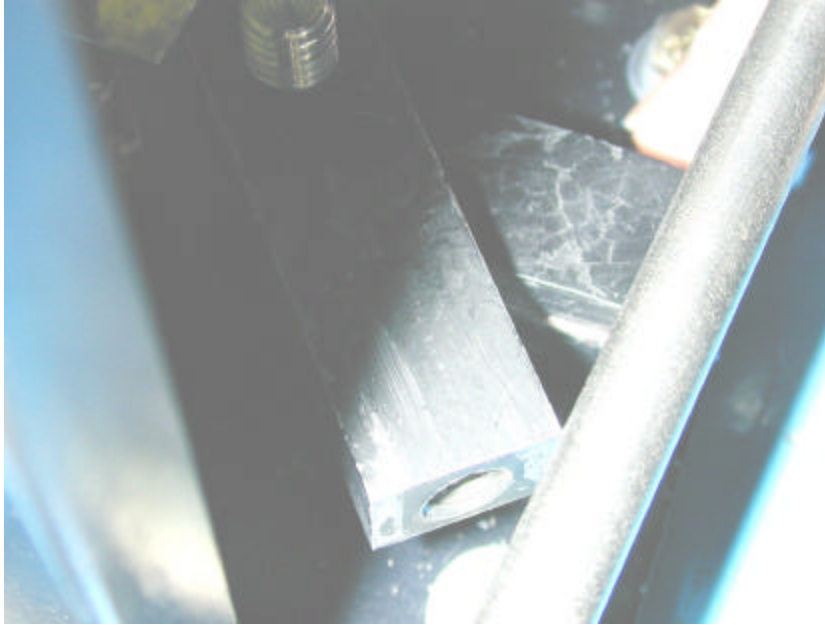
Detail showing how the mounting blocked with the lift arm removed from the threaded hole is no longer constrained by the locking bar in the right side of the picture.

In the event of a major transportation accident involving the release of the load from its confinement on the transport vehicle, it is conceivable that the single source projector could have fallen into a horizontal orientation that might have permitted the source to slide into the open position. If this had happened in the shipment from Fermilab to the vendor, the "old" source being in the open position represented a potential accidental exposure rate of 18.6 R/hr at one meter. If this had happened in the return shipment, the "new" source being in the open position represented a potential accidental exposure rate of 64.4 R/hr at one meter. It is important to add that upon receipt, radiation surveys and detailed inspections of the shipping containers indicated that the transportation was accomplished in an orderly manner and free of incidents. For both the outgoing and incoming shipments, the container and the source projector was found to be correctly oriented with the source in its shielded position. It was thus determined that no measurable radiation exposures were attributable to these shipments.

This event resulted from the inadvertent reliance on a lower level of administrative control (i.e., keeping the single source projector upright) when a higher level (locking the source down) was intended. The concern is that the source was not handled and stored in a manner commensurate with the hazards associated with a source of this level of activity. It is also noted that the vendor likewise overlooked this potential problem in the course of preparing the return shipment. Clearly, more attention to the effectiveness of the vendor-supplied controls and the equipment developed in house would have prevented the event. Given the long periods of time between servicing of these projectors,
